Department
for Education

Managing Older Buildings:

A guide for estates maintenance staff

April 2024

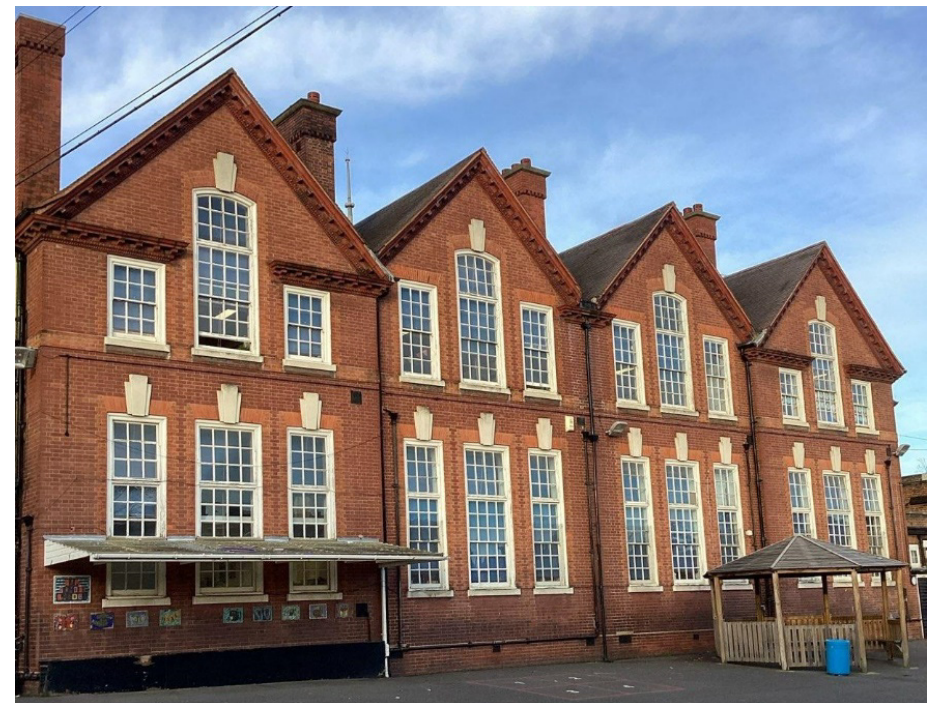
Figure 1: Example of pre-war traditional school construction

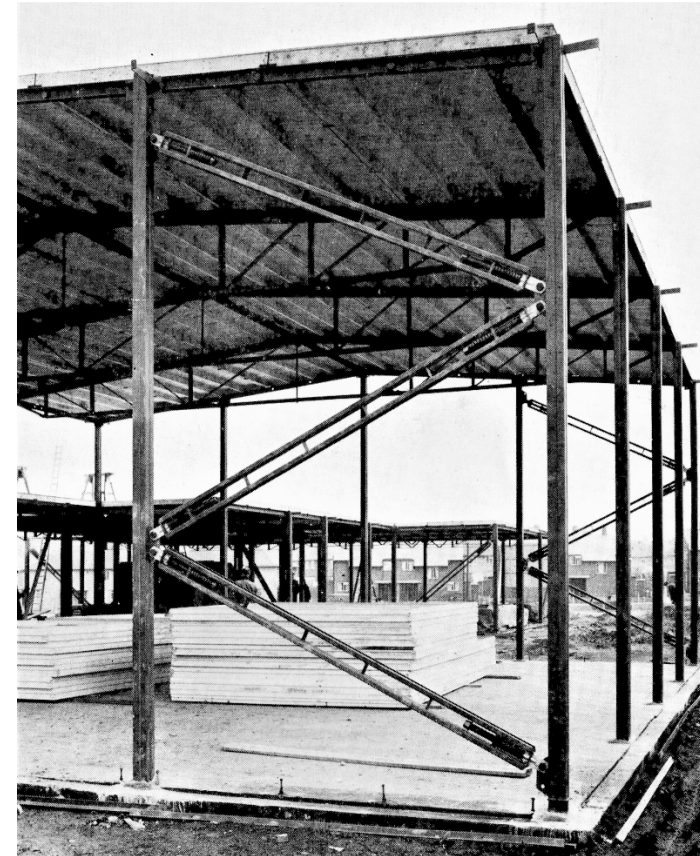
In some cases, the consortia developed a single system, for example CLASP (with its distinctive bracing design). In other cases, they developed a range of solutions using different materials, for example SEAC (steel, concrete and masonry systems). Private suppliers included Orlit and Derwent (also known as Vic Hallam). Further details of these systems are provided in Appendix A.

Figure 3: Example of a post-war system build (CLASP)

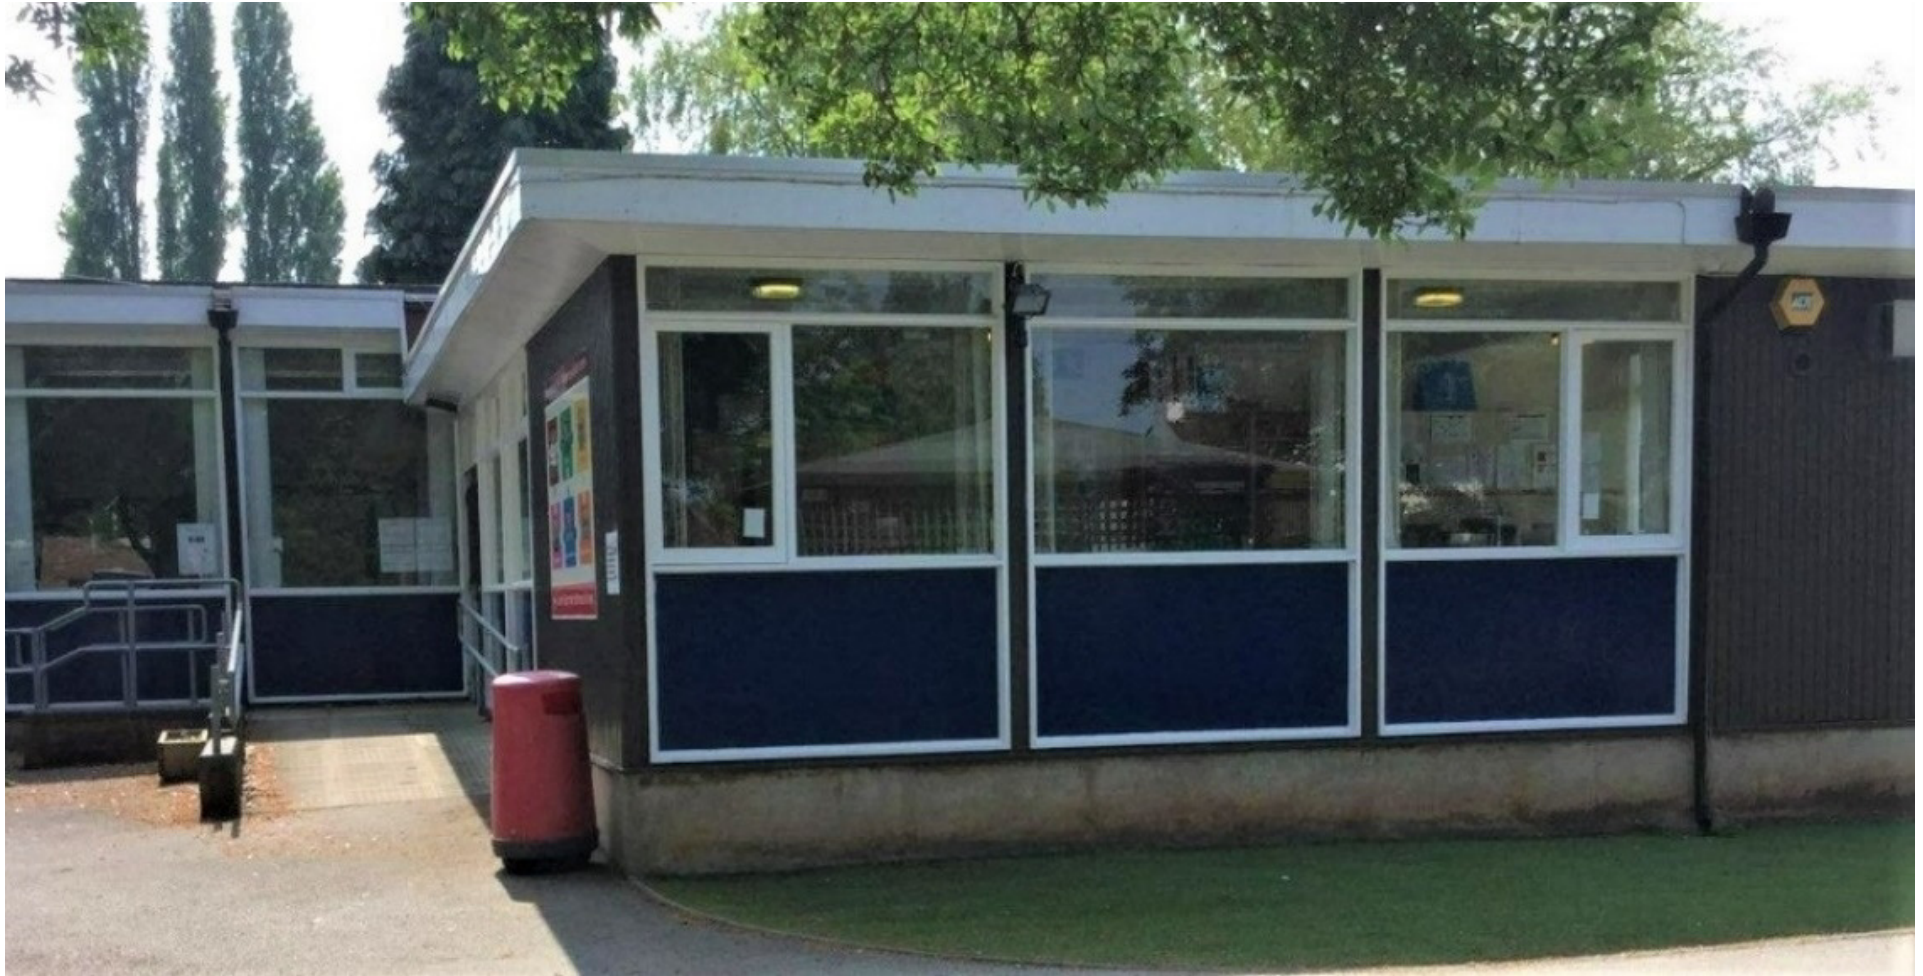
Figure 8: Example of Derwent school accommodation

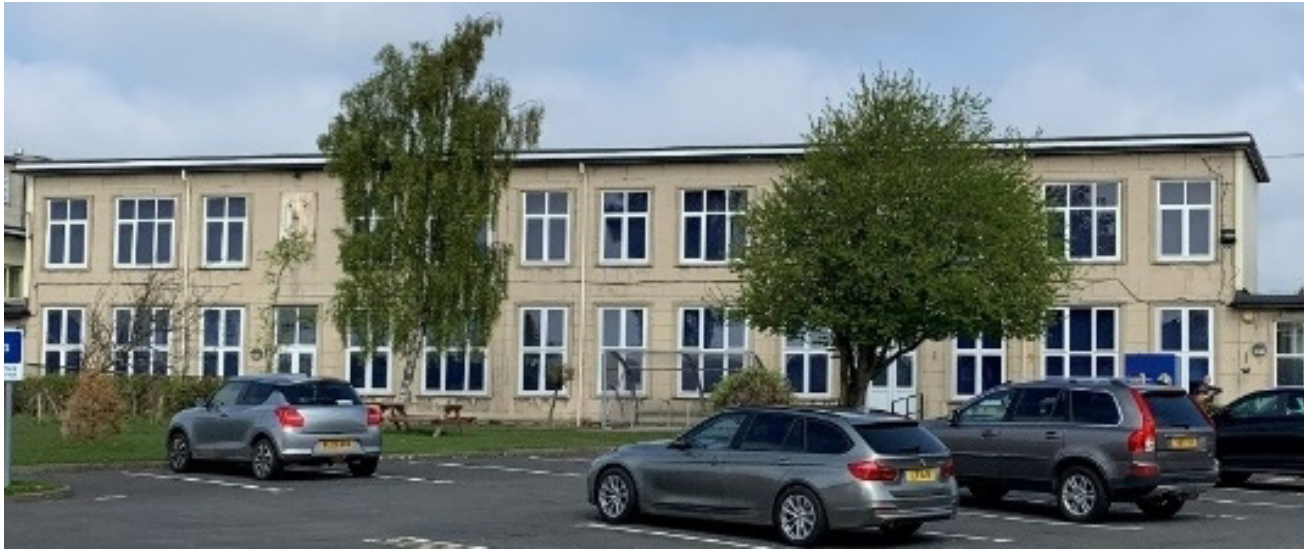
Figure 15: Example of Orlit school accommodation

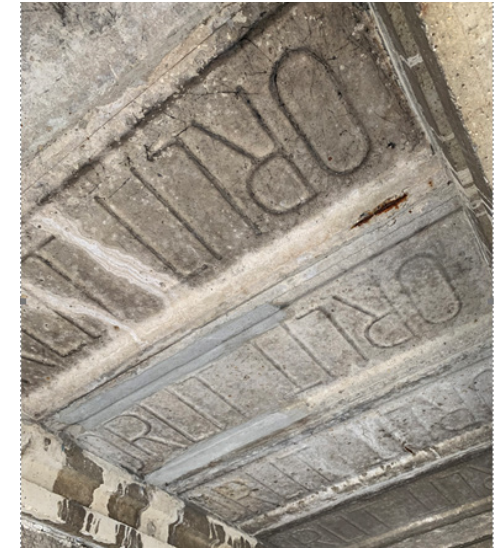
Figure 16: Orlit soffit

Note: Slabs are not always imprinted with 'Orlit'.

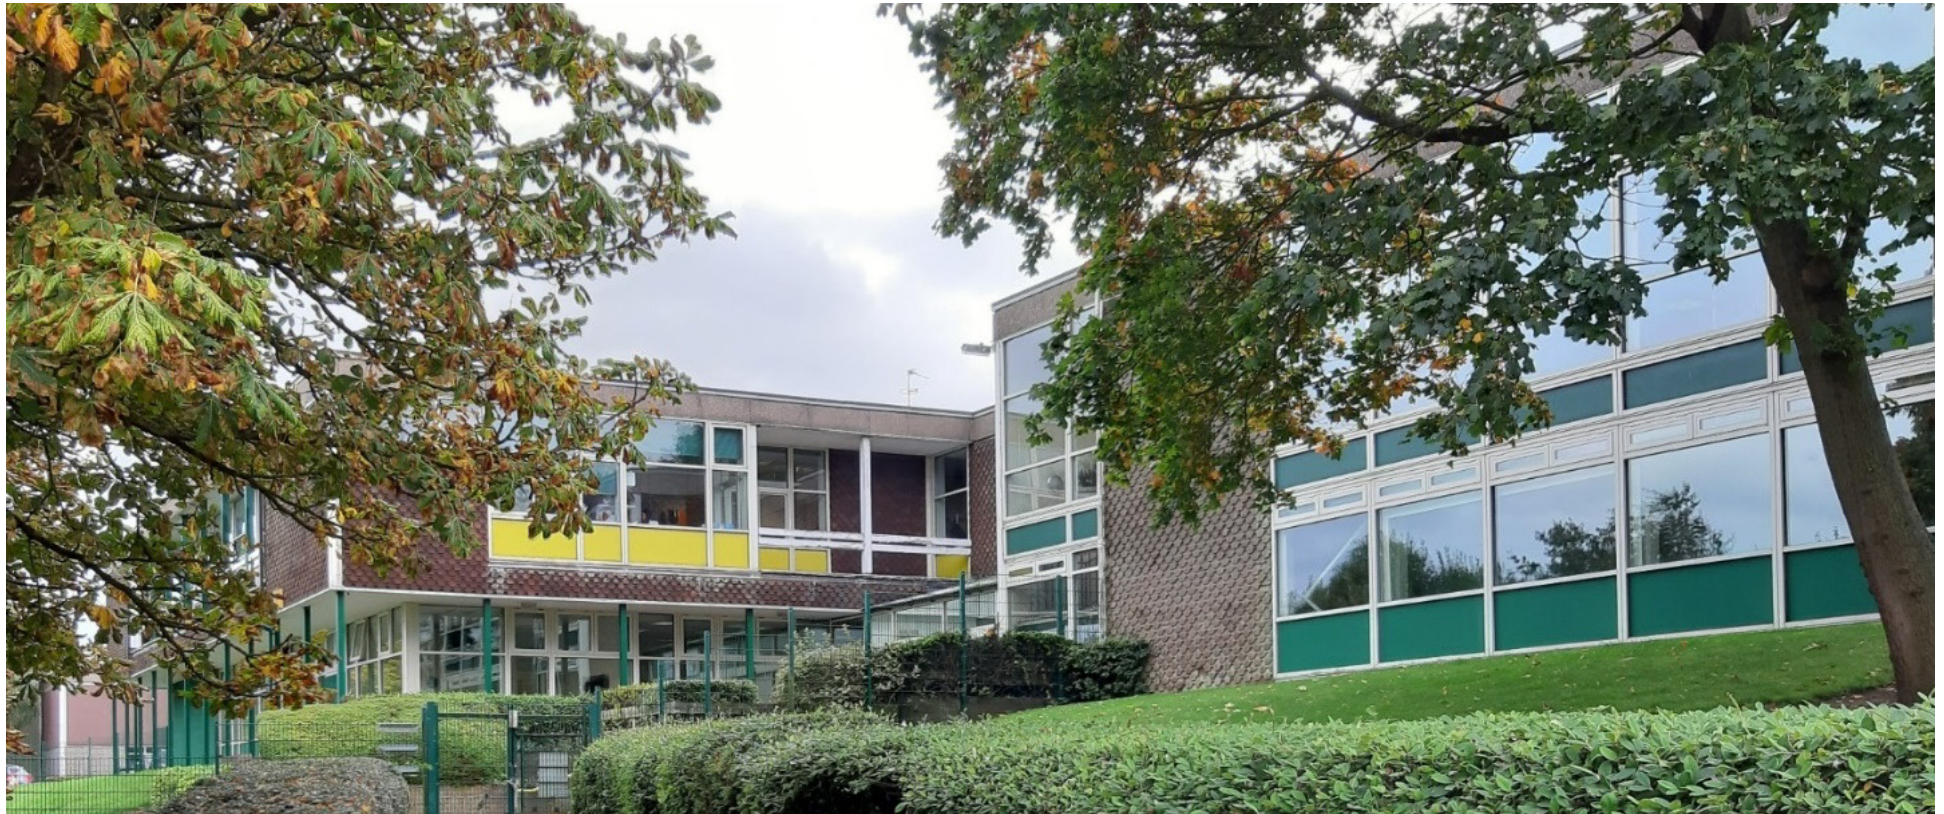
Figure 17: School constructed with CLASP
